**HILLVIEW RESERVOIR
WESTCHESTER COUNTY
NEW YORK
INVENTORY NO 187**

**PHASE I INSPECTION REPORT
NATIONAL DAM SAFETY PROGRAM**

JULY 1978

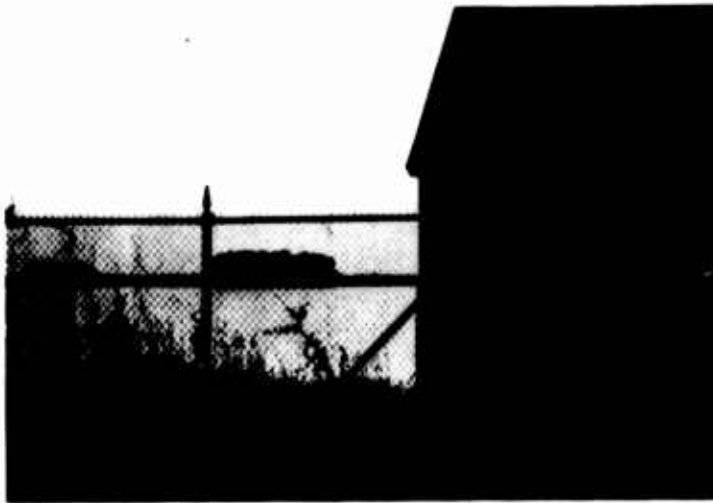
1. View of reservoir looking past downtake #1.

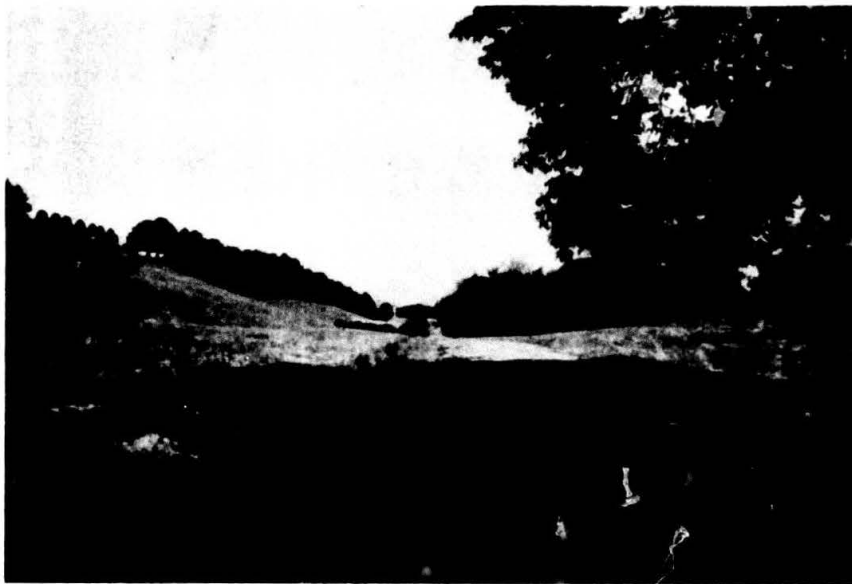
4. Another view looking west along property access road.

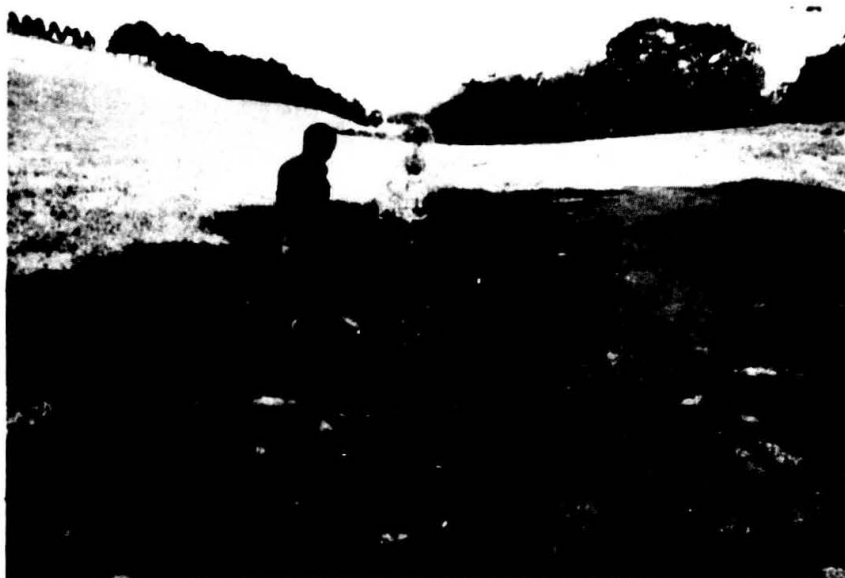
5. Detail of local drainage works along access road at toe of embankment.

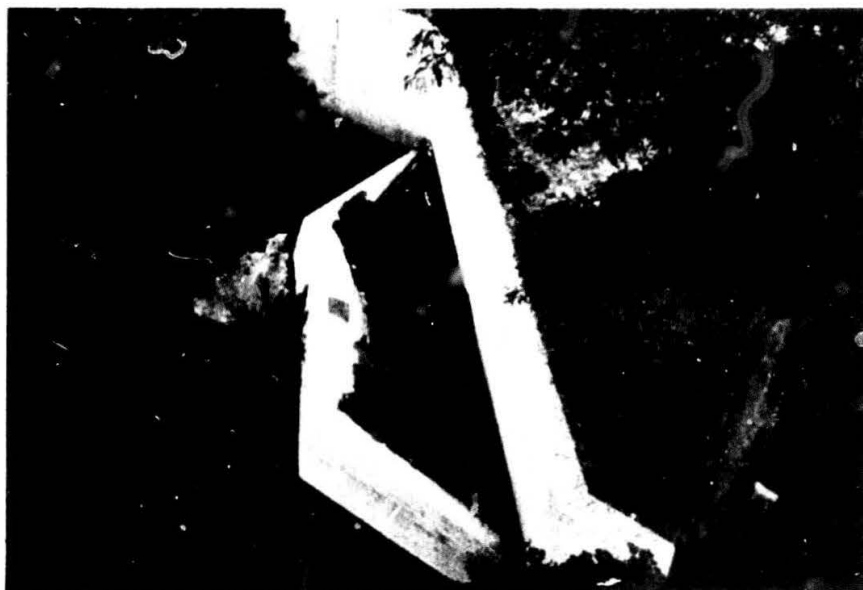
7. View of Wakefield Street outfall into Bronx River. No discharge at time of inspection.

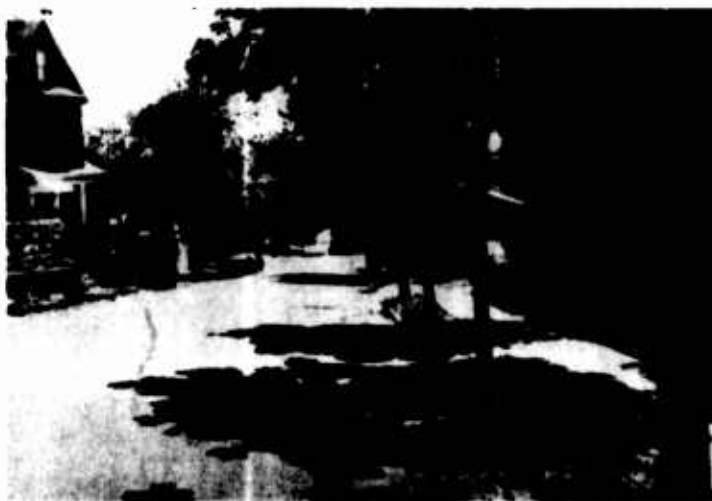
10. View of Wakefield Street area east of reservoir.
